## Milford Road Rockfall The Pinnacle

Document Date 20 May 2013

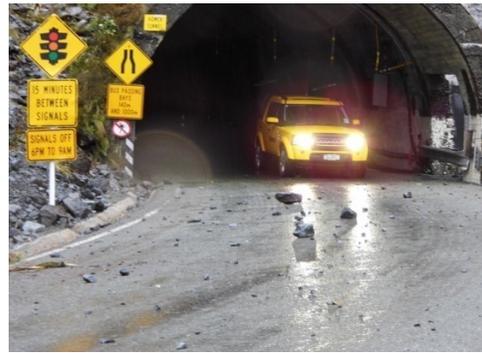
*Pieces of rock that hit the Milford Road at the western entrance to the Homer Tunnel after a section of the "Diamond Pinnacle" high above the tunnel entrance broke off in November 2012.*

During routine inspection on 11 November 2012 the NZ Transport Agency's Milford Road contractor came across rocks on the road at the western portal of the Homer Tunnel. Further investigation showed that a large section of rock had broken away from a feature known to climbers as the 'Diamond Pinnacle' on a bluff high above the road.

What remained of the pinnacle on the bluff was a 20-plus metre, 2000 tonne column of rock which presented stability concerns.

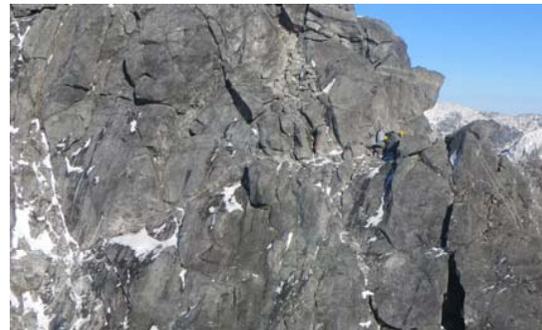
*Rope access lines that have been secured to the rock face allow workers to move safely around the rock fall site.*

The monitoring and inspection continued with additional checks after heavy rain and earthquakes. At the same time we also commissioned an aerial survey of the rock mass, to develop a 3D picture, followed up by a detailed rope access inspection on the bluff.

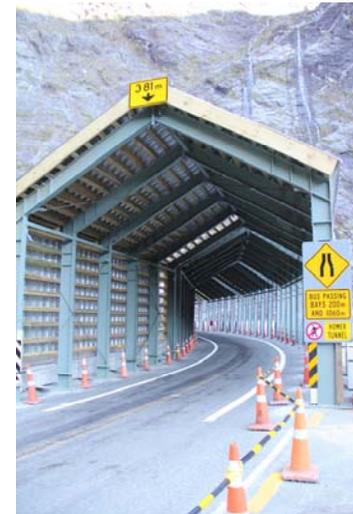
*A temporary portal extension at the western entrance to the Homer Tunnel that opened in February 2013 helped the road return to close to normal operations.*

The priority at this point was protecting road users. We were able to provide improved 24/7 access to users by mid-February following the construction of the temporary portal extension to provide protection from rockfall.

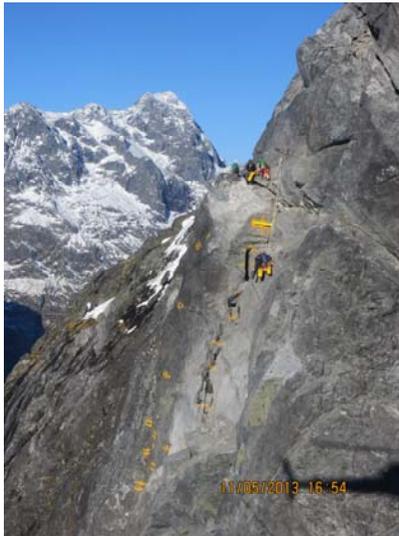
*High altitude geotech experts carrying out rock face marking work.*

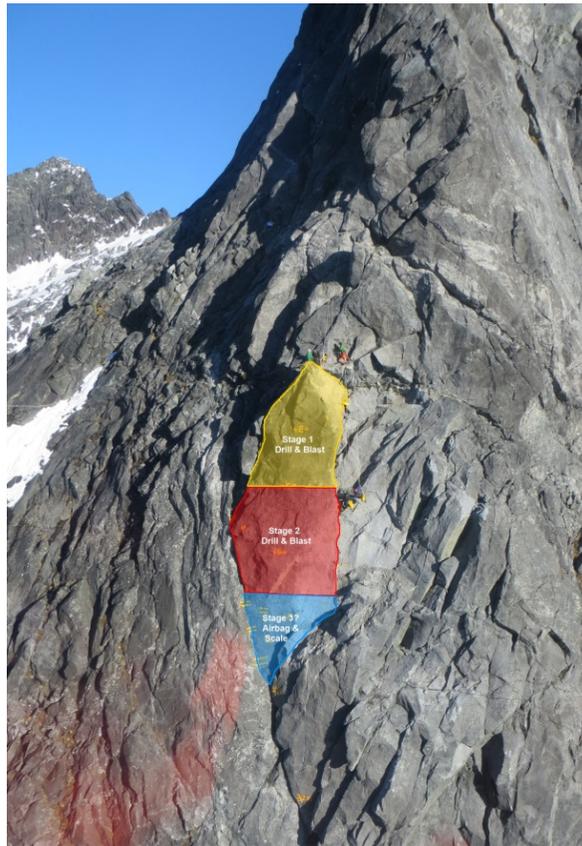
*The unstable rock feature will be removed in the three stages shown above.*

We have looked at all practical options to remove this feature and concluded that drilling and blasting is the only feasible and effective option. Once we start drilling we cannot be assured of reasonable stability within the pinnacle feature, so for safety reasons we cannot allow traffic through the tunnel after this work has started. To work at this height it is essential that we complete the work before the onset of winter, which gives us a limited working window of opportunity.

Therefore, it is necessary to close the road around and through the tunnel while this work is being undertaken, which will mean no road access to or from Milford through the tunnel for this period. We expect the first drill, blast and stabilise cycle to take around 10 to 14 days, but this work is weather dependent, and a further drill, blast, stabilise cycle may be required.
